Waterway to the Neusiedlersee

Critical thoughts about the intervention and
consequences to our environment

Krstic Tijana – Nagy Zsuzsanna – Spachinger Karl

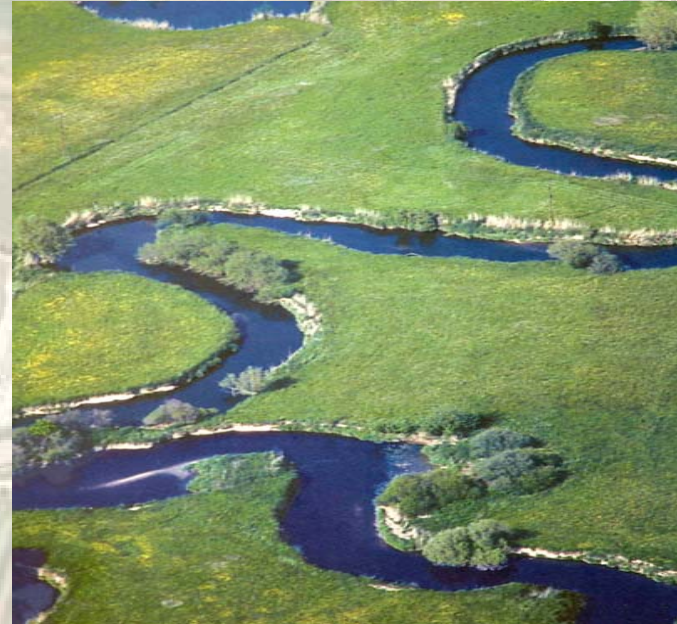
Ecological Waterway

Appearance

- Meandering
- Riparian area
- Continuously on the surface
- Using on-site material
- On-site vegetation
